# INSPECTION REPORT

For the Property at:  
**JOB #45XXX -- 1234 SOMEPLACE DRIVE**  
CITY, BC VXX XXX

Prepared for: XXXXXXXXXXXXXXX  
Inspection Date: XXXday, MONTH ##, 2011  
Prepared by: XXXX XXXXX, RHI, CPBC lic.4####

James Dobney Inspections  
#63 - 1833 Coast Meridian Road  
Port Coquitlam, BC V3C 6G5  
Metro Vancouver | 604.942.8272  
Abbotsford & East | 604.854.1516

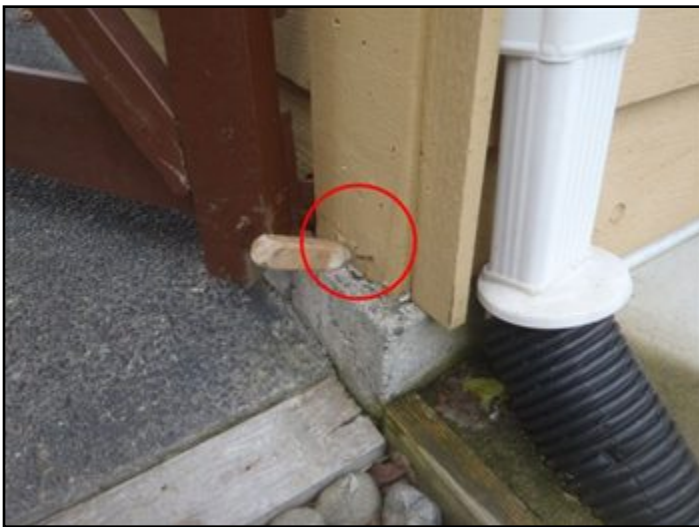
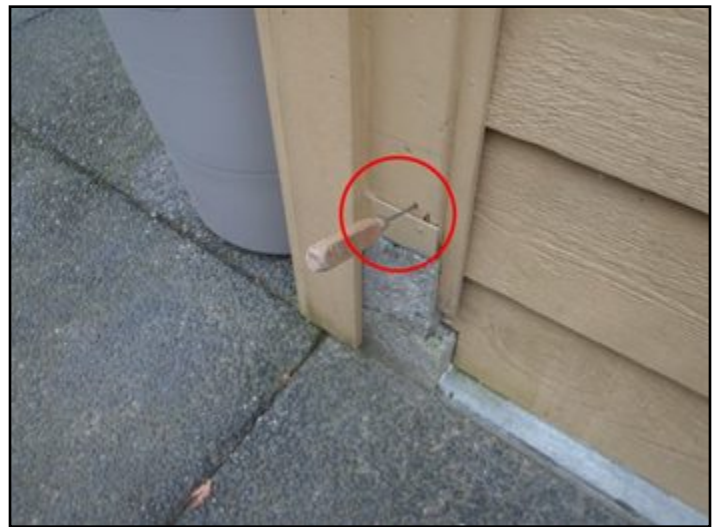
### POSTS/COLUMNS \ 5.3

**Condition:** • Rot

Immediate safety issue, told sellers about the posts needing replacing. Possible hidden damage.

**Location:** North Deck

*Rotted post bottom*

**Task:** Replace Further evaluate & repair

**Time:** Immediate

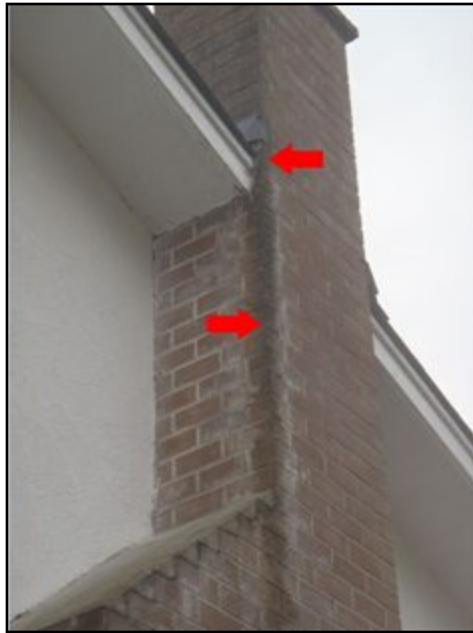
### **FLASHINGS - CHIMNEY \ 2.5**

**Condition:** • [Suspect](#)

Water should not be running down the chimney which is causing some damage. Repair.

*Water run-off path noted*

**Task:** Repair Further evaluate & repair

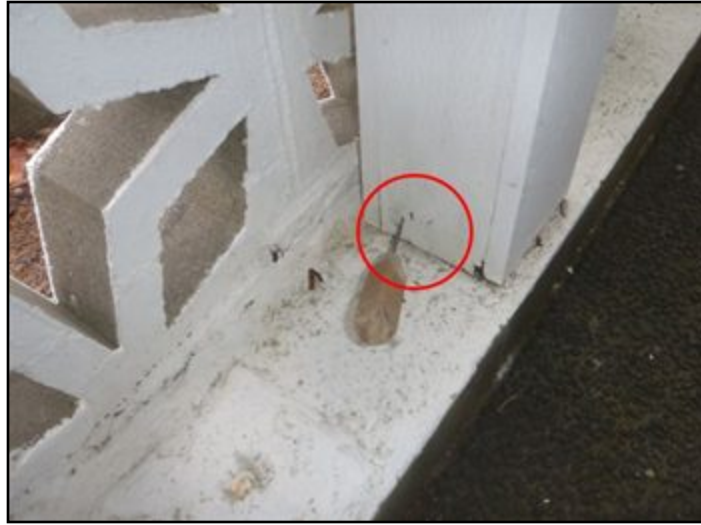
**Location:** Deck**Task:** Repair Further evaluate & repair**Time:** Immediate**CARPORT \ 6.0****Condition:** • Rot found in Carport post, inspect all posts and repair.**Location:** Carport**Task:** Repair Further evaluate & repair**Time:** Immediate

*Rot in Carport post*

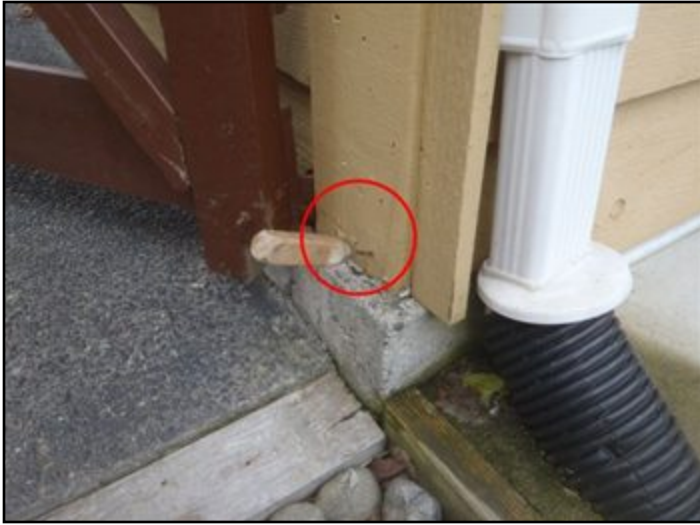
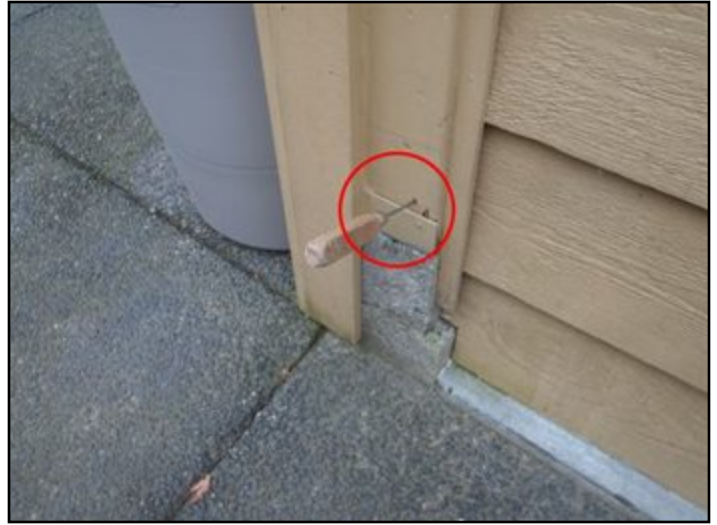
**Condition:** • Rot

Immediate safety issue, told sellers about the posts needing replacing. Possible hidden damage.

*Rotted post bottom*

**Task:** Replace Further evaluate & repair

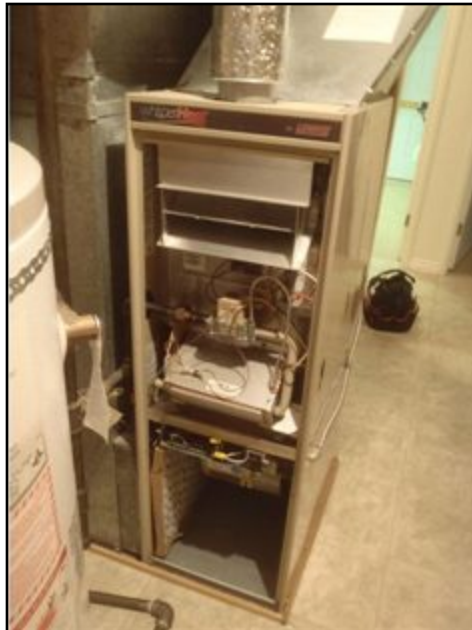
**Condition:** • Service when you move in.

*Furnace*

**Task:** Service

**Time:** Immediate Ongoing

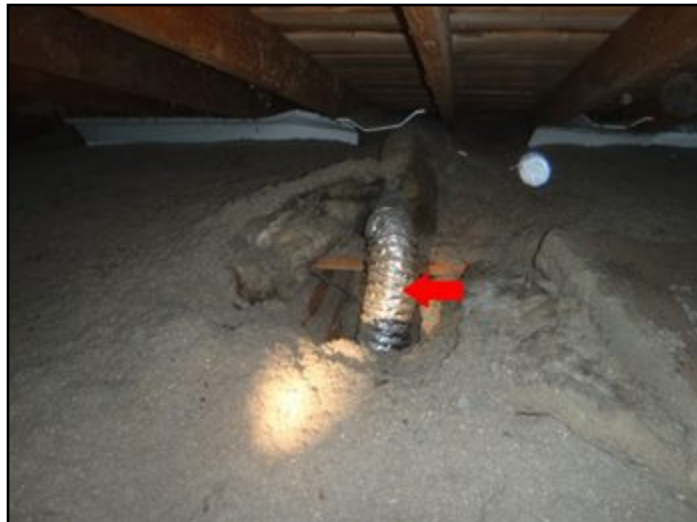
**Condition:** • [Duct insulation missing or incomplete in unheated areas](#)

*Kitchen fan ductwork*

**Task:** Repair

**Time:** Immediate

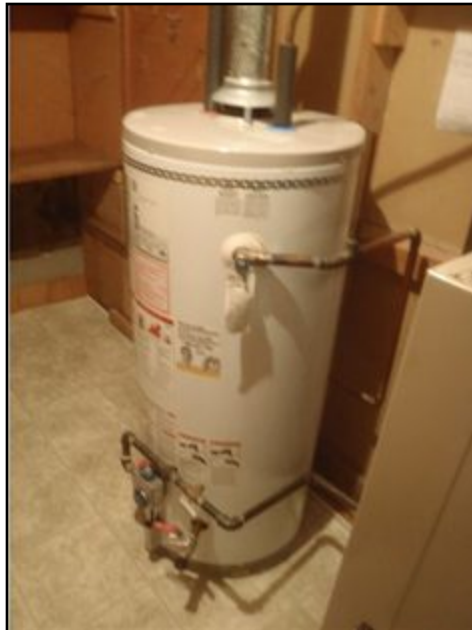
**Condition:** • [Near end of normal life expectancy](#)

Generally Water Heaters last 8 - 12 years, this tank is 7 years old, budget for replacement.

*Water Heater*

**Task:** Replace

**Time:** Unpredictable

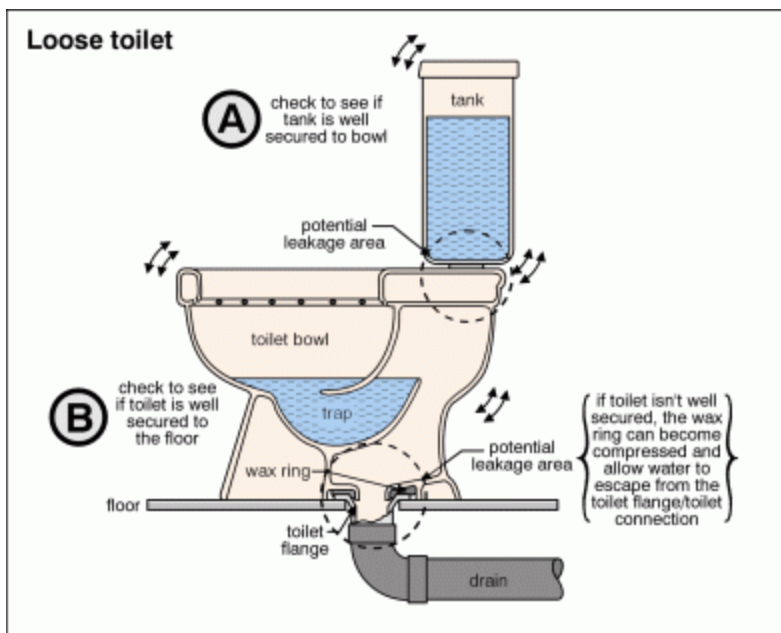
**Condition:** • [Loose](#)

Both toilets require new wax rings on the main floor, possible floor damage.

**Task:** Repair Further evaluate & repair

**Time:** Immediate
